CIVIL AERONAUTICS BOARD

ACCIDENT INVESTIGATION REPORT

COMPANIA CUBANA DE AVIACION, S. A. AND U. S. NAVY,
KEY WEST, FLORIDA, APRIL 25, 1951

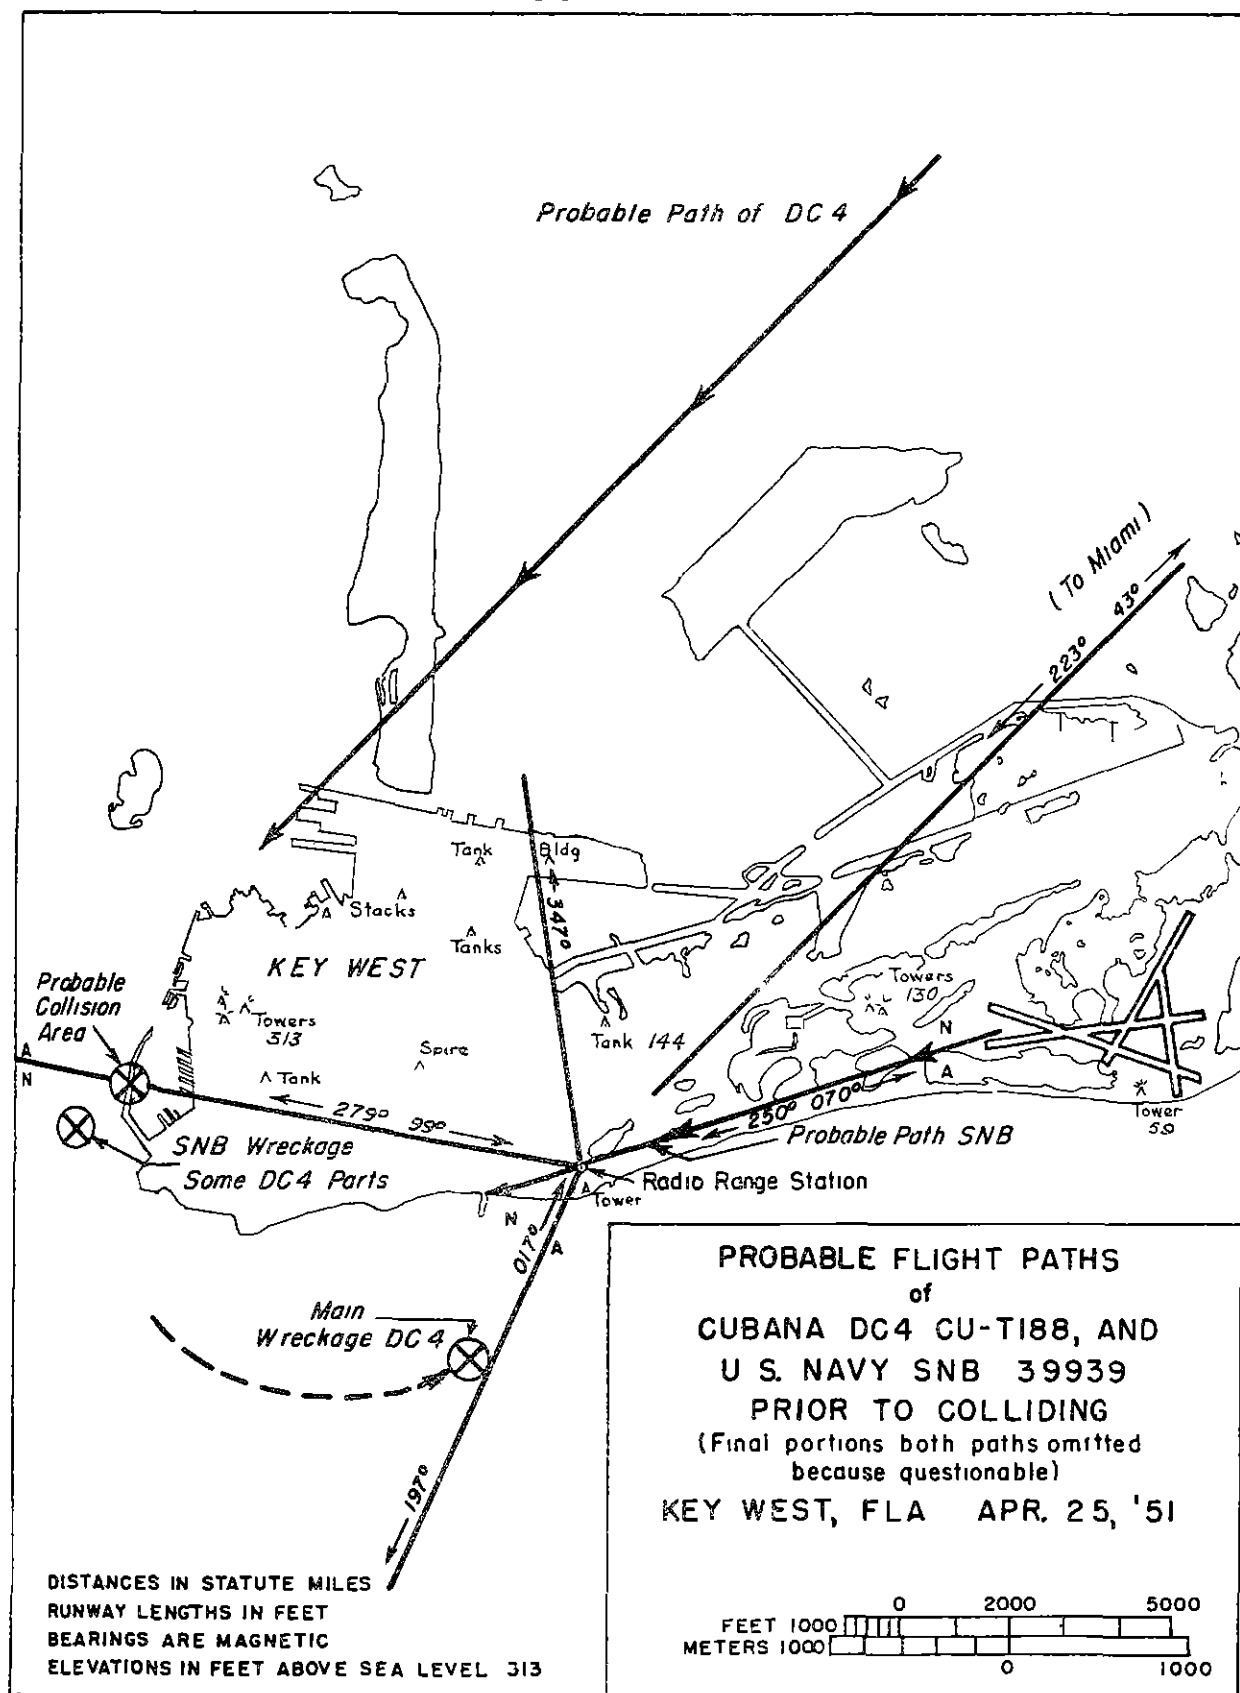
Appendix I

On the morning of the same day a twin-engine Beechcraft, Navy designation SNB No 39939, was scheduled for a simulated instrument training flight from the U S Naval Air Station,⁵ Key West, Florida, at 1120 The flight, to be conducted under visual flight rules, had no altitude or area assignment other than that necessary to accomplish the training mission One portion of the mission requires a flight inbound on the east leg of the Key West Radio Range on a heading of 250° M, at an air speed of 140 knots Upon recognition of the cone, the pilot proceeds outbound on the west leg of the range on a heading of 279°, reduces speed to 105 knots, lowers the landing gear and descends to an altitude of 1,300 feet A procedure turn is then made and the prescribed pattern followed for a simulated instrument approach to Boca Chica Airport (See Appendix I)

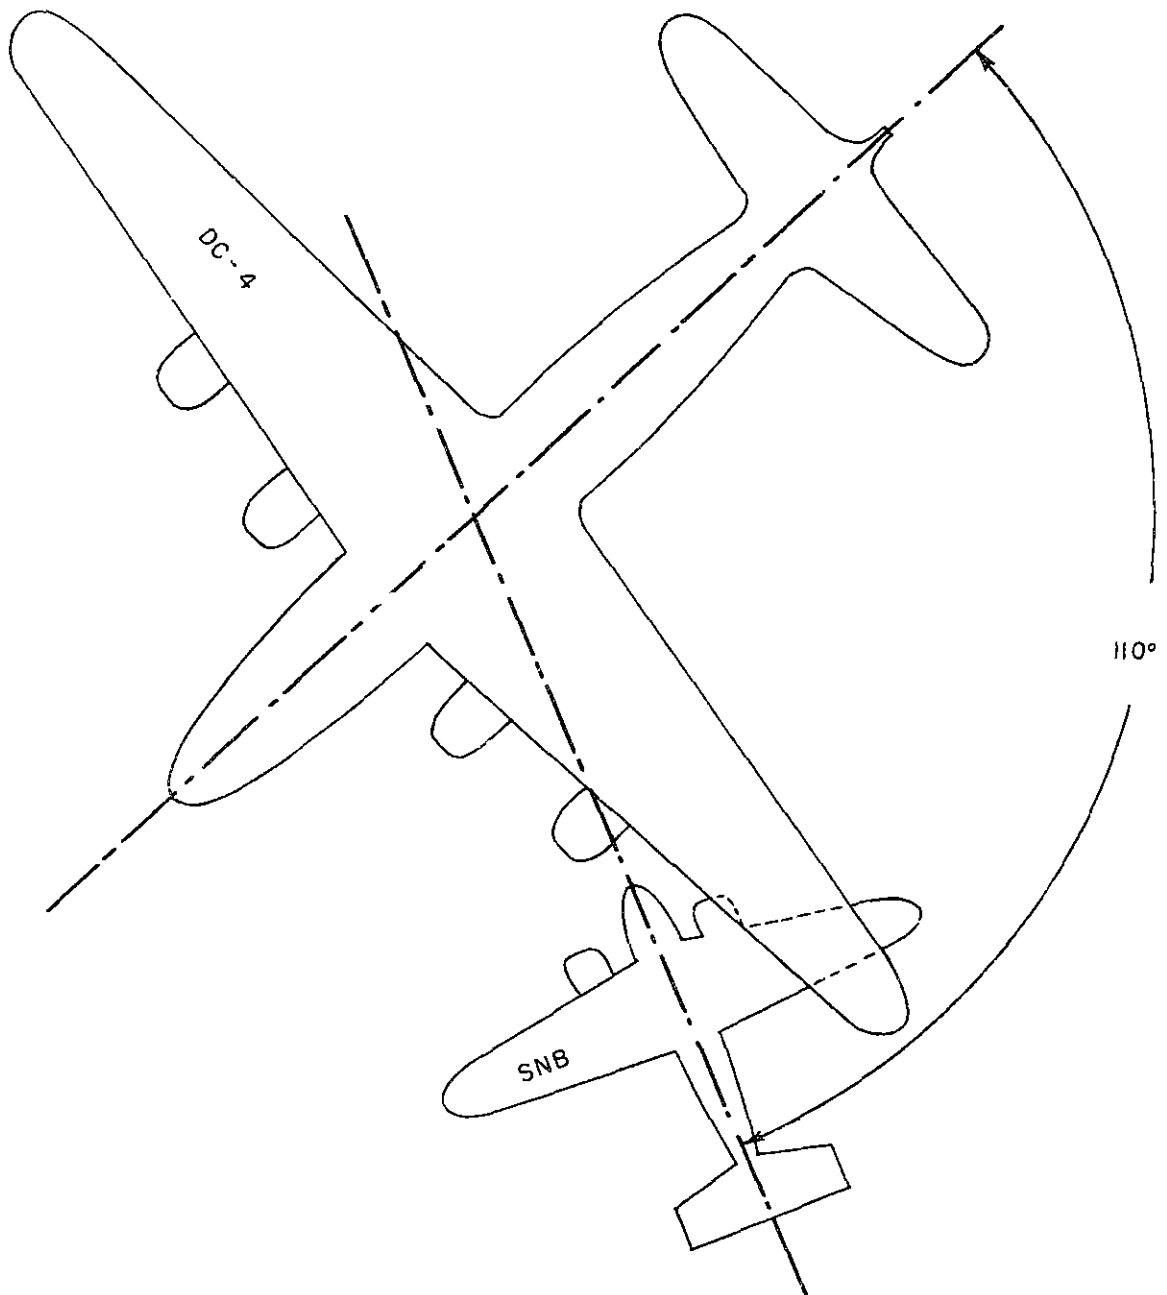
Appendix II

Among the recovered portions of both aircraft, sufficient evidence was found to establish the position of the aircraft relative to each other at the moment of initial impact. The right propeller of the SNB had deep gouges on the leading edge of both blades. The section of the DC-4 left wing recovered with the SNB wreckage showed evidence of having been cut by a revolving object at wing stations 588 1/2 and 540 1/2, the cutting action being from the front to the rear of the wing and parallel to the longitudinal axis of the DC-4. The cut on the DC-4 left wing at station 588 1/2, which was made by one blade of the right propeller of the SNB, was the first contact between the two aircraft. The cut in the DC-4 left wing at station 540 1/2 by the second blade of the SNB right propeller, and the contact of the tip and leading edge of the DC-4 left wing with the

right side of the SNB fuselage, followed almost simultaneously. There was evidence of subsequent impact between the two aircraft, however, the damage was of such a nature that it was not possible to determine any sequence of events. The SNB propeller cuts in the DC-4 left wing indicated that the angle between the longitudinal axis of the two aircraft at the moment of impact was approximately 110° . (See Appendix II)

ANGLE OF COLLISION AS DETERMINED BY EXAMINATION OF WRECKAGE
CUBANA DC-4 CU-T188 AND U S NAVY SNB 39939
KEY WEST, FLA APR 25, '51
